Manhole Inspection Summary

Manhole # S29CC1032MH

Insp Date: **12/12/06 12:32 PM**

Location Address: **634 BERRY ST**

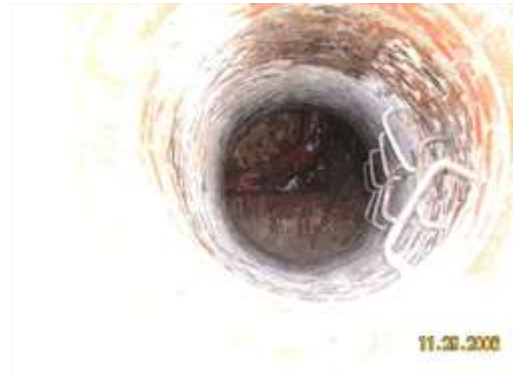
Top View

Bench debris.

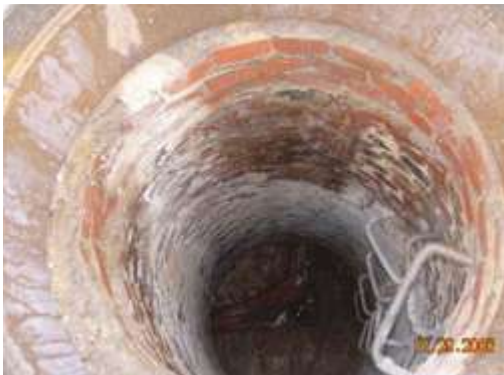
Defect

Frame leaks. Frame offset. Adjustment deterioration and infiltration. Cobel and Barrel infiltration.

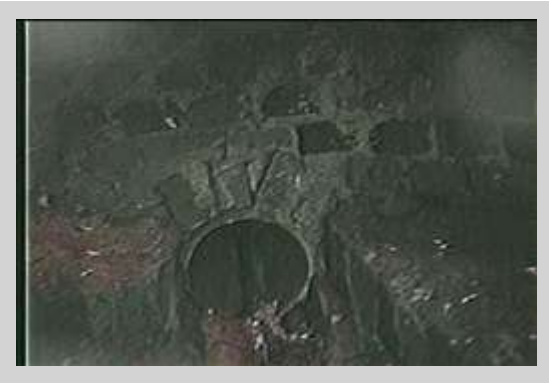
8 in. Circular Gravity Sewer Pipe Out @ 12 O'Clock

Deposits: ☐ None ☐ Mud ☐ Sludge ☒ **Debris** ☐ Grease

Infiltration: **Evidence** Pipe Seal Cond: **Cracked**

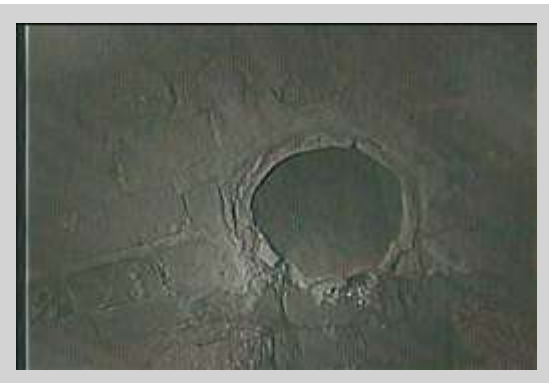
6 in. Circular Gravity Sewer Pipe In @ 9 O'Clock

Infiltration: **Evidence** Pipe Seal Cond: **Cracked**
